| Title of Document | Space Shuttle Challenger Salvage Report, T9597-AA-RPT-010/SUPSALV, 0910-LP-140-9100, Published By Direction of Commander, Naval Sea Systems Command |

SPACE SHUTTLE CHALLENGER SALVAGE REPORT

29 APRIL 1988

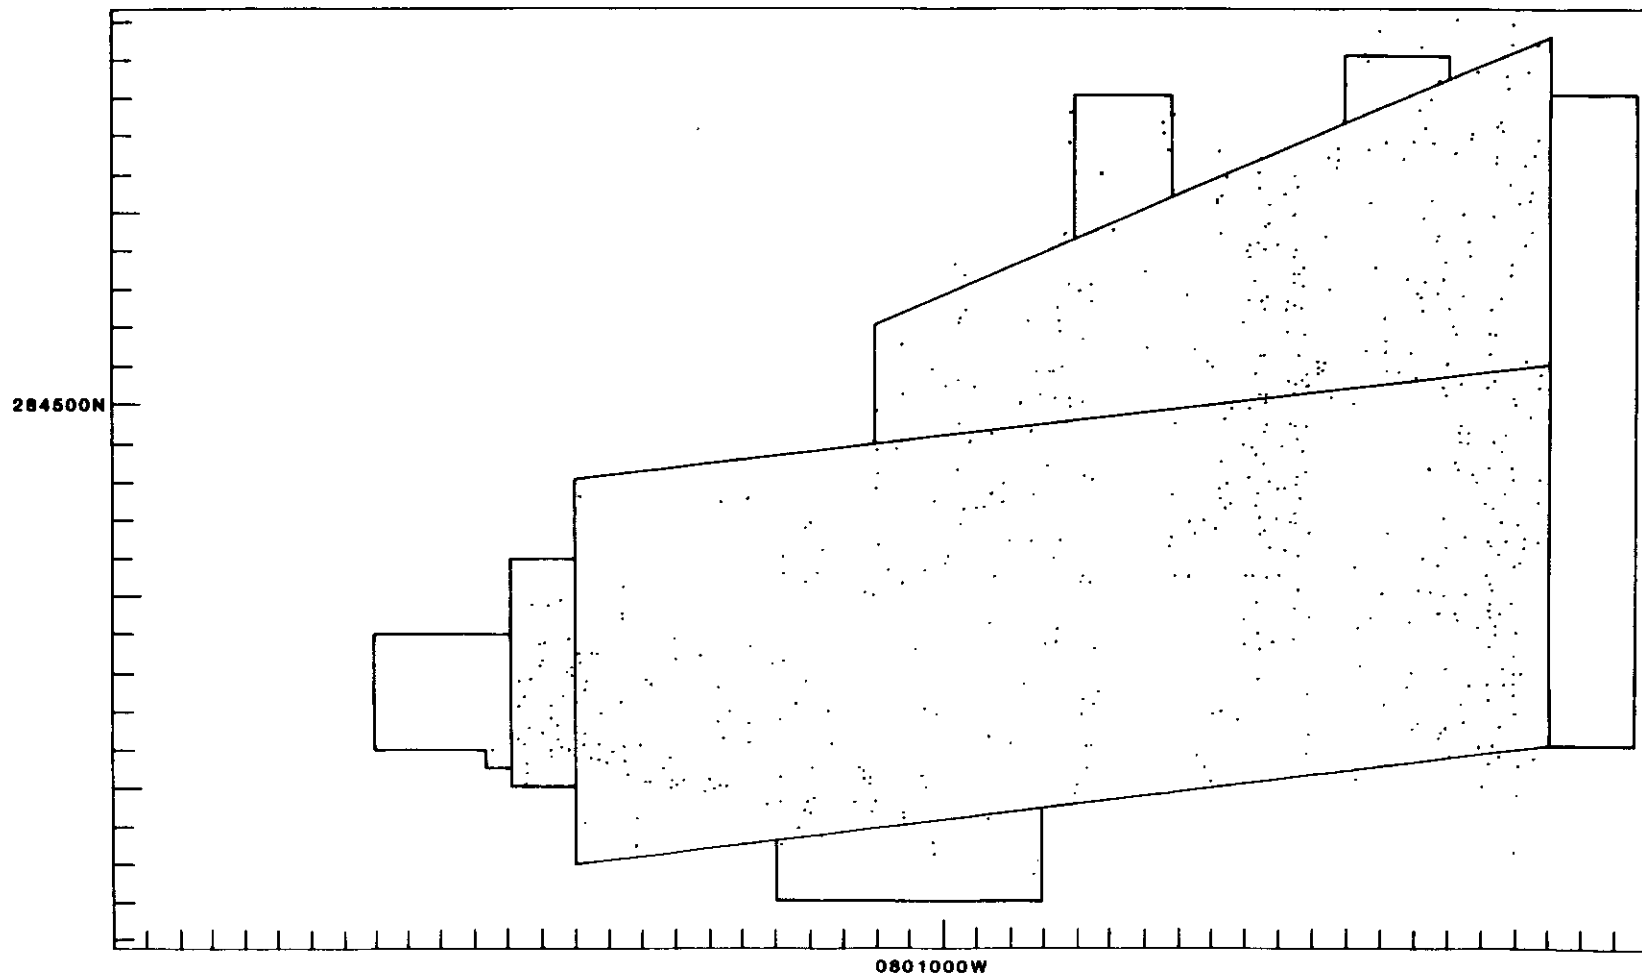
Exhibit 13. Distribution of 881 Designated Sonar Contacts

4.2 Contact Summary. From 8 February through 29 August 1986, a total of 881 contacts were designated from the sonar traces during the search, of which 711 were ultimately investigated using divers, ROV's, or manned submersibles. Of these 187 were confirmed to be shuttle-related, two were identified as aircraft, thirteen were shipwrecks, and another thirteen were determined to be debris from previous launches at the Cape. Some 112 contacts were miscellaneous scrap such as sinks, 55-gallon drums, old buoys, and rigging from cargo or fishing vessels. The remaining contacts were either geological in nature or nothing conclusive could be

5.3 SRB Classification. A comparative look at Exhibits 13 and 17 reveals the tremendous number of designated sonar contacts to be visually classified, a relatively small number of which would ultimately prove to be SRB related. Because of water depths and surface currents in the eastern half of the search area, surface supplied divers could not be used, and employment of DEEP DRONE was severely limited by surface current drag on the umbilical. Therefore, the task of SRB classification initially fell almost exclusively to the SEA-LINK I and SEA-LINK II submersibles. Occasionally GEMINI was utilized but that ROV's primary mission was recovery. Because of environmental, target dispersion, and vehicle endurance

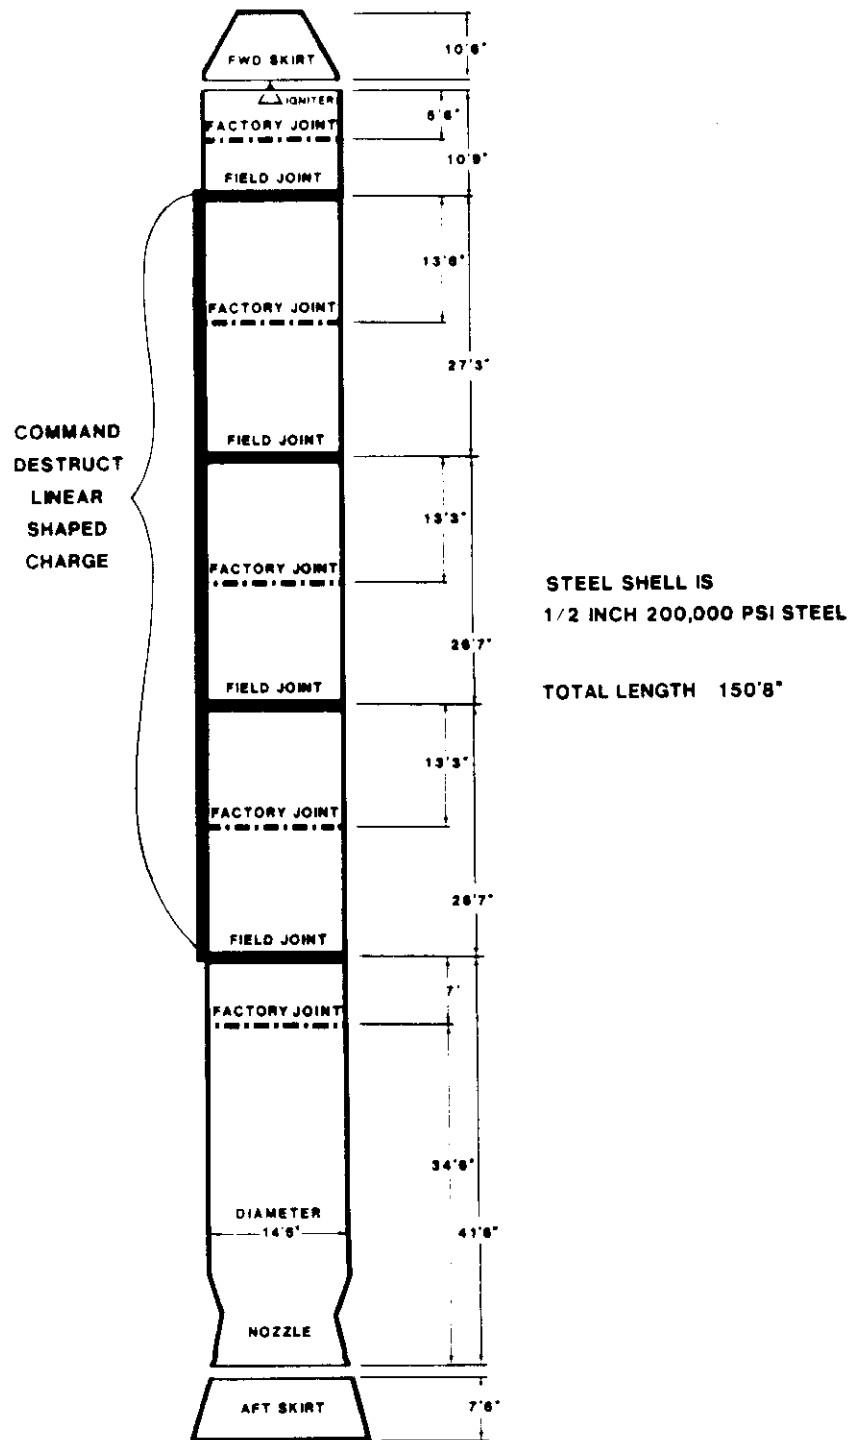
Exhibit 15. Arrangement of Typical SRB

5.1 SRB Configuration. The primary mission of the deep water salvage operation was the recovery of the critical sections of the suspected burned-through joint of the right SRB. NASA had reviewed the shuttle design and photographic evidence from the launch and had concluded that the most probable cause of the CHALLENGER mission explosion was a failure of the right SRB lowermost field joint. At 0.678 seconds into the flight, photographic data and analysis showed a strong puff of grey smoke spurting from the vicinity of this joint at the 270 to 310-degree sector of the circumference. NASA believed that the lower field joint on the right SRB had failed, releasing burning gasses which ignited the liquid hydrogen-oxygen fuel in the External Tank and caused the catastrophic explosion. Exhibit 15 shows the arrangement of a typical SRB. Exhibit 16 shows the geometry and nomenclature of a typical SRB joint. NASA required physical evidence for proper evaluation of the failure. Another objective was recovery of other sections of the SRB for additional analysis. The salvage mission was successful in that the critical sections of the right SRB were retrieved and the majority of other SRB debris was recovered. Success did not come, however, without significant challenge from the environment and the SRB targets themselves.

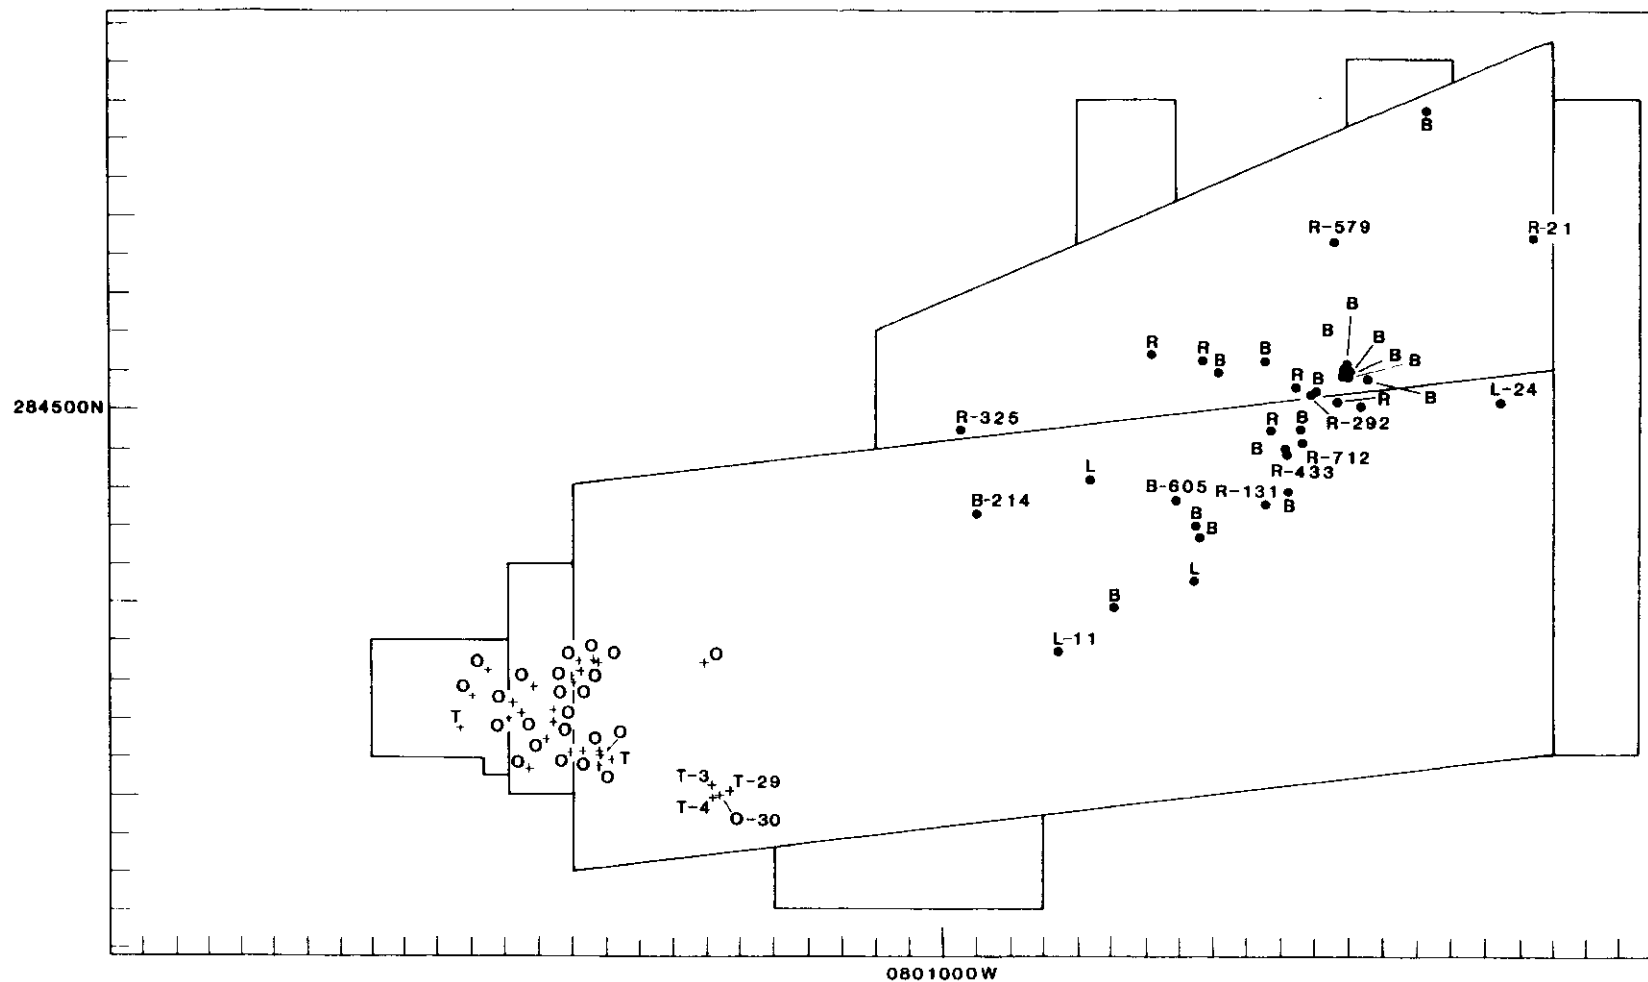
Exhibit 17. SRB and Orbiter Debris Areas

5.2 Distribution of SRB Debris. Fragmentation of the SRB's at high altitude resulted in many small pieces being dispersed over a wide area. Exhibit 17 shows the overall dispersion of shuttle debris. The right and left SRB debris fields were co-mingled but were exclusive from the Orbiter, external tank and payload debris field. It must be emphasized, however, that this tremendous SRB debris dispersion was not initially known or even suspected. At first the debris fields found at Contacts #21 and #24 were suspected to contain the entire right and left SRB's respectively. Only after much later radar, visual and structural data analysis, supported by an emerging pattern from recovered debris of random SRB dispersion over vast areas, was the true nature of SRB disintegration correctly determined. In point of fact, when the range safety officer detonated the linear shaped charges, each of the nine joints (four field joints and five factory joints) on each SRB failed catastrophically. Six of the resulting ten "cylinders," already open at the 0° location due to the linear shaped charge cut, opened up and failed at 180° and in most cases again at approximately 90° and 270°, thus dispersing a "checkerboard" of steel plating from an altitude of 13 miles and at an initial relative rate of 100 to 250 miles per hour (mph) transversely and in excess of 2,000 mph axially. The two SRB sections aft of the rearmost factory joint, having the greatest mass, impacted the sea intact at the eastern most sites at Contacts #21 and #24. Structurally adjacent components of the right SRB were found separated by over seven miles. Exhibit 18 shows the distribution of SRB contacts along the failed field joint circumference.

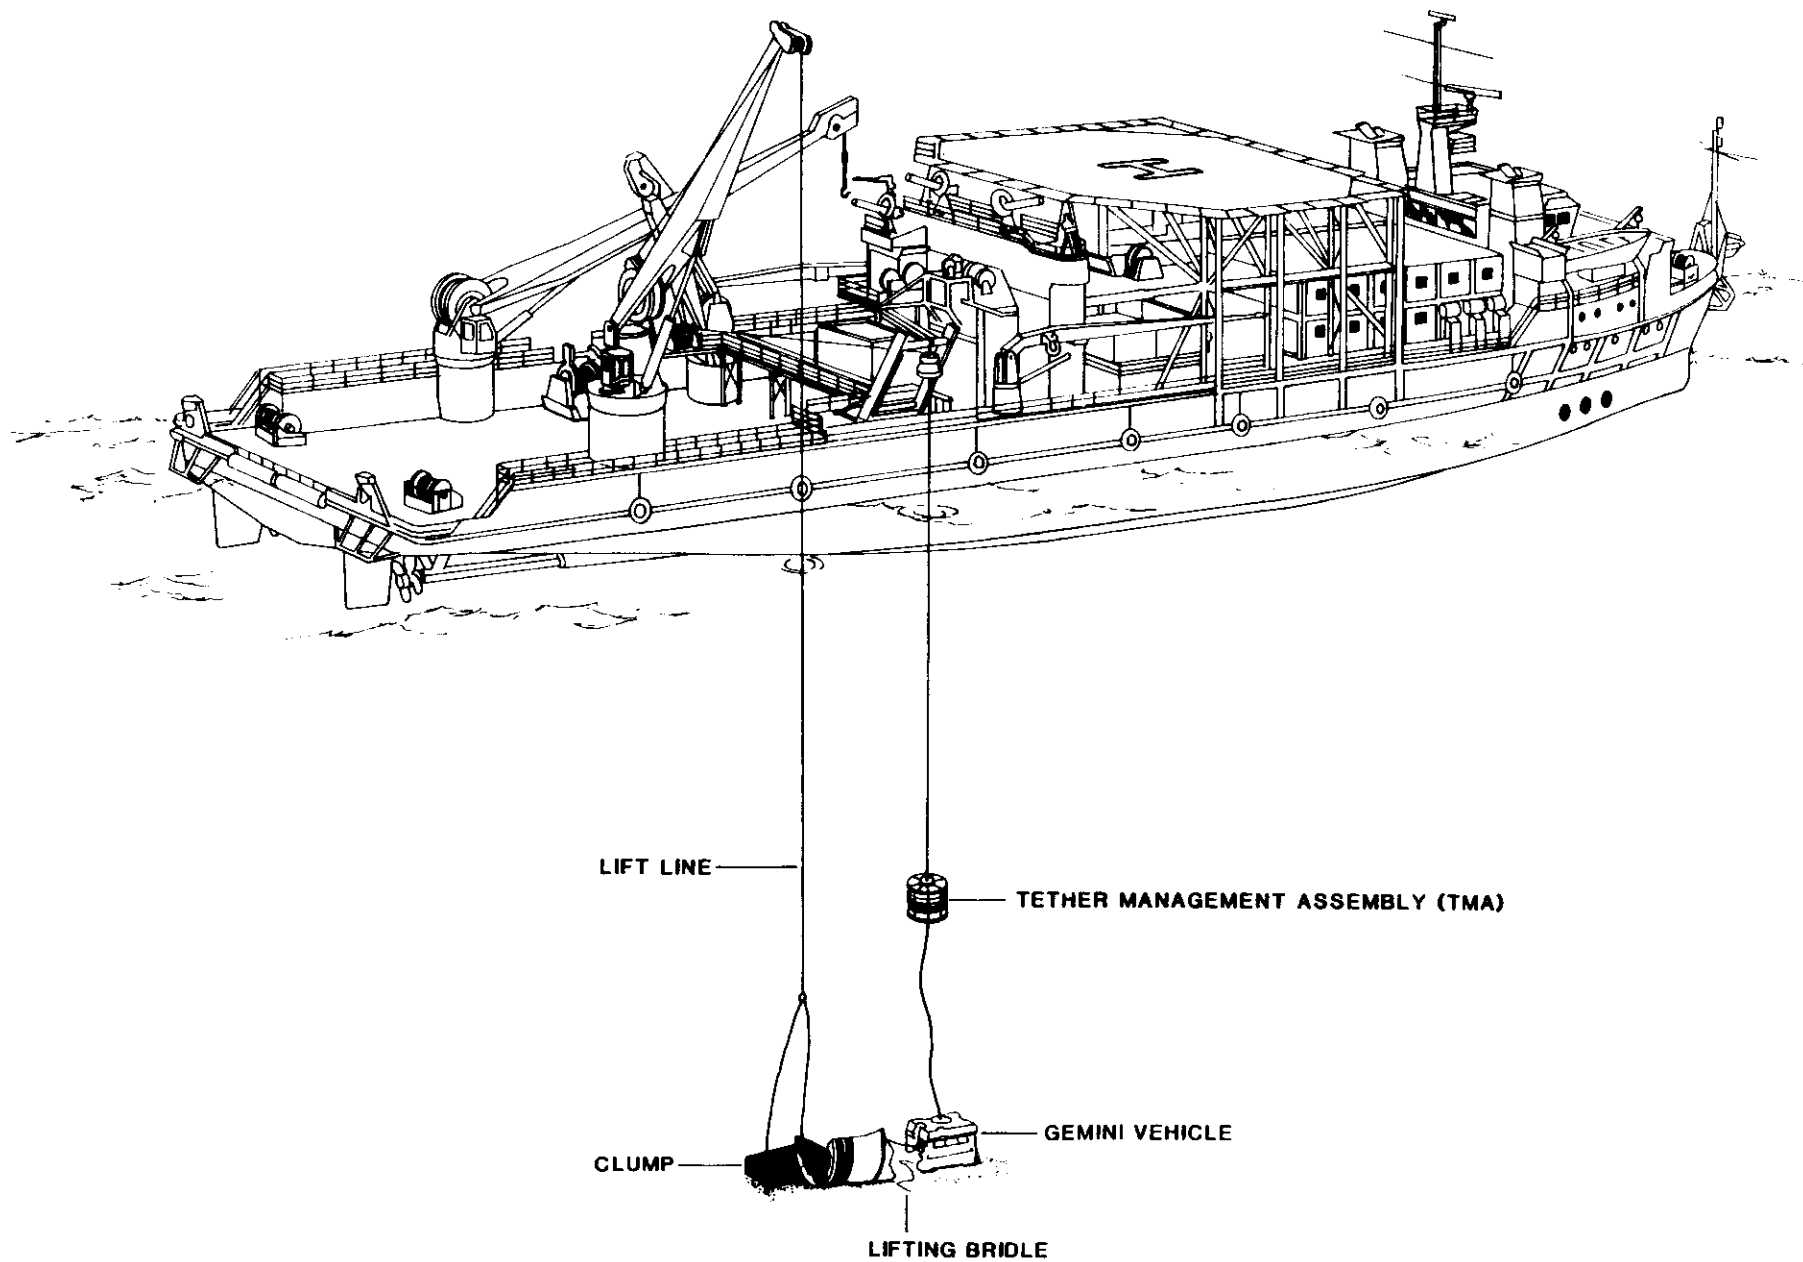
Exhibit 21. STENA WORKHORSE and GEMINI Configuration

- A kevlar line below the clump was loosely faked and fastened in place with plastic tie-ties near the clump. The bitter end of this whip was rigged so that it pulled away from the clump in short lengths rather than all at once. On the end of the whip was a snap hook with a handle for the ROV manipulator to facilitate attachment to the target's preattached lifting pendant.

- When the ROV was safely back onboard STENA WORKHORSE, the target was hauled up until the chain clump was alongside. The clump was then lifted on deck and cut loose from the lift line. The lift continued until the target piece was landed and secured to the deck. NASA and Explosive Ordnance Disposal personnel would immediately inspect the debris and prepare it for transit and storage.

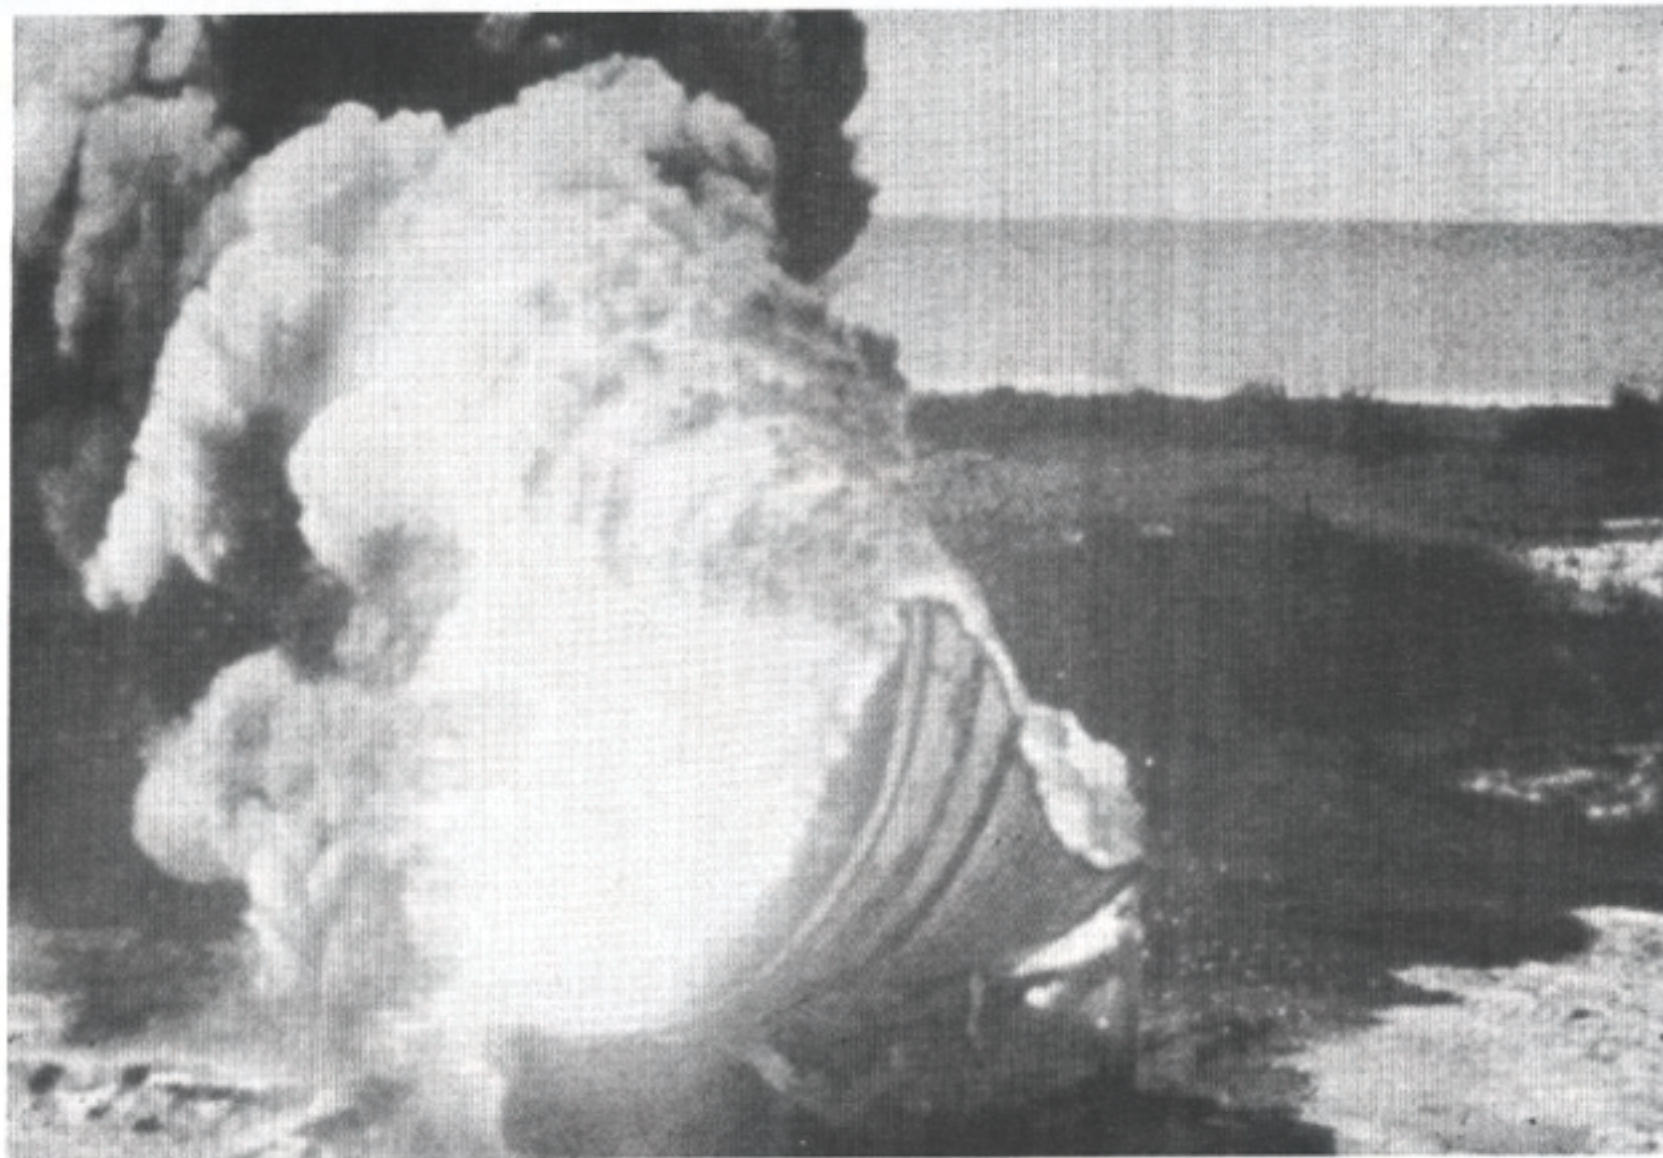
Exhibit 22. Propellant Burning from a Booster Piece

5.6.2 Propellant. Unexpended solid rocket propellant was extremely hazardous and required precautions to prevent ignition. The SRB propellant burns at temperatures in excess of 5,000° F and tended to become unstable with emersed time. Recovered parts containing propellant were kept wet and care was taken to avoid shear or sparking between hard surfaces while handling. Open flames and direct heat were kept away. Once offloaded ashore SRB parts containing propellant were taken to an ordnance burn area where the propellant was safely ignited before the part was taken to the reconstruction area for analysis. Exhibit 22 shows the burning of propellant from a booster piece.

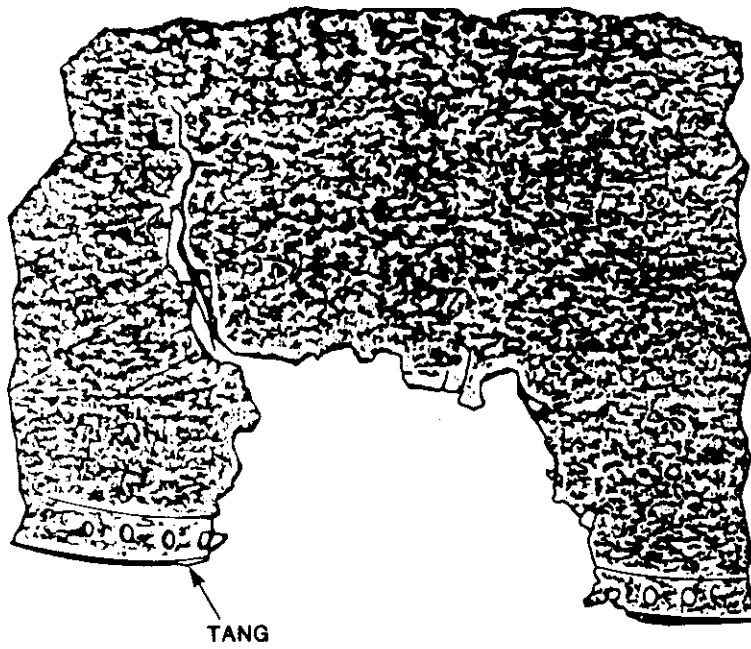
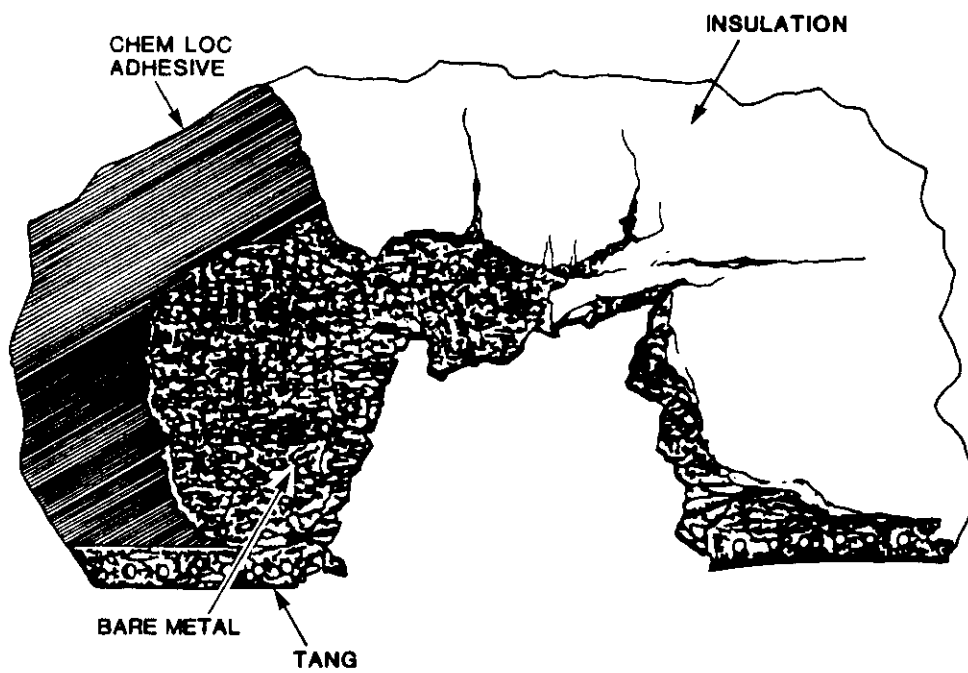
Exhibit 23. Contact #131 Interior and Exterior Surfaces

5.9 Recovery of the Right SRB Critical Joint. The recovery of Contact #131 typifies the successful result of the concept of operations wherein several major assets were sequentially utilized to locate and recover the target. Contact #131 was the right SRB aft center segment containing the tang portion of the joint burn through area, Exhibit 23. This contact was initially located on 1 March 1986 by LIBERTY STAR in 560 feet of water using side scanning sonar. At that time the magnitude of SRB dispersion was not known and its location was in the left SRB trajectory area. Thus it was assigned a low priority for classification. NR-1 operated at the site of Contact #131 on 5 April, classified the contact as probable STS 51-L debris and videotaped the contact. After a review of the NR-1 videotape by SUPSALV and NASA engineers, visual evidence of possible burned areas raised its priority markedly and the manned submersible SEA-LINK I, operating from EDWIN LINK, was assigned to investigate the contact. On a dive conducted on 12 April 1986, SEA-LINK I onboard observers verified that Contact #131 was badly burned and scarred. A wire pendant was attached to a tang section and a pinger

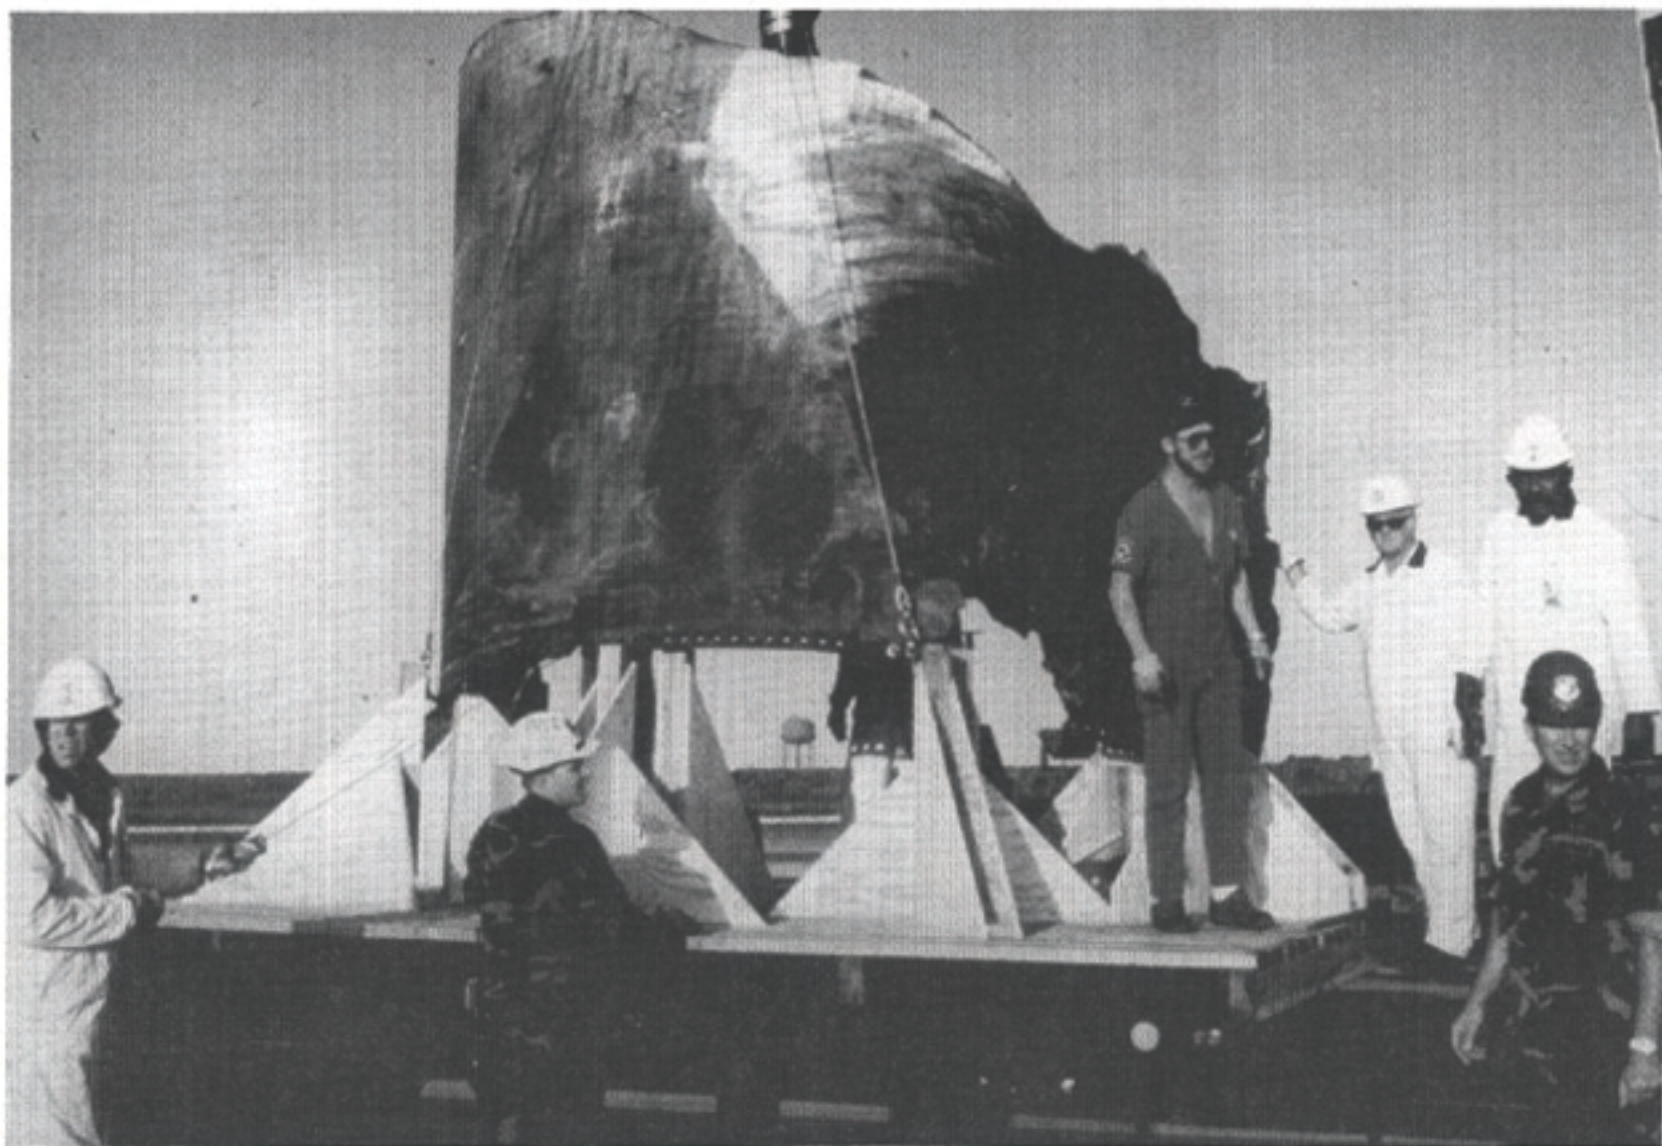
Exhibit 24. Contact #131 Recovery Right SRB

deployed. STENA WORKHORSE was immediately assigned to conduct recovery. Using the ROV GEMINI, STENA WORKHORSE attached a lift line and recovered the piece on 13 April 1986, Exhibit 24.

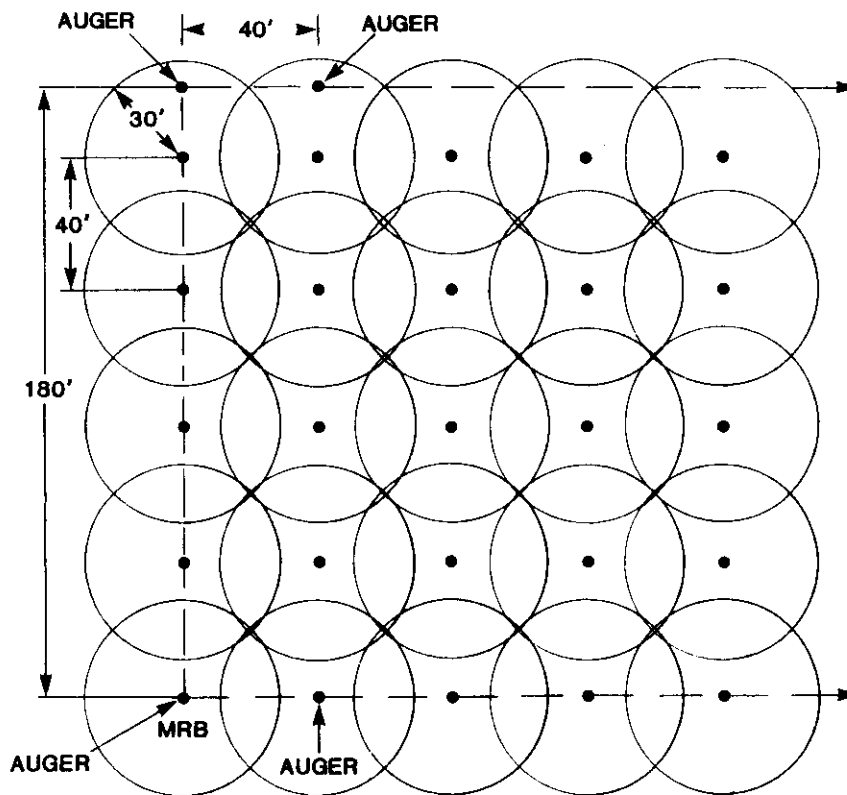
Exhibit 32. Combined Jack-stay and Circle Method

6.3.2 Combined Jack-stay Search Methods. The combined jack-stay and circle search method employed for locating buried debris with metal detectors purposely included significant overlap to eliminate the possibility of missing very small objects. Exhibit 32 shows the search pattern. A reference buoy was initially dropped on datum at the intended search area. Divers then placed an auger anchor on the sea floor at datum and established a north-south base line 180 feet long by compass swim. The base line was knotted every 40 feet and fixed at the ends with auger anchors. Similar base lines were placed parallel to the first and 40 feet apart. Divers then conducted a series of circle searches along each base line with metal detectors. Each circle had a 30-foot radius from an auger at one of the knots on the base line. Divers covered the area by searching a series of 5-foot wide concentric circles. One diver would swim the circling line around the auger while the second searched along the line with the metal detector. When a buried object was detected it was dug up and placed in a central location for recovery at the dive's end. The areas were prioritized for search by the debris pattern detected during the earlier search with a towed metal detector and visual searches of the sea floor by divers using diver propulsion vehicles.

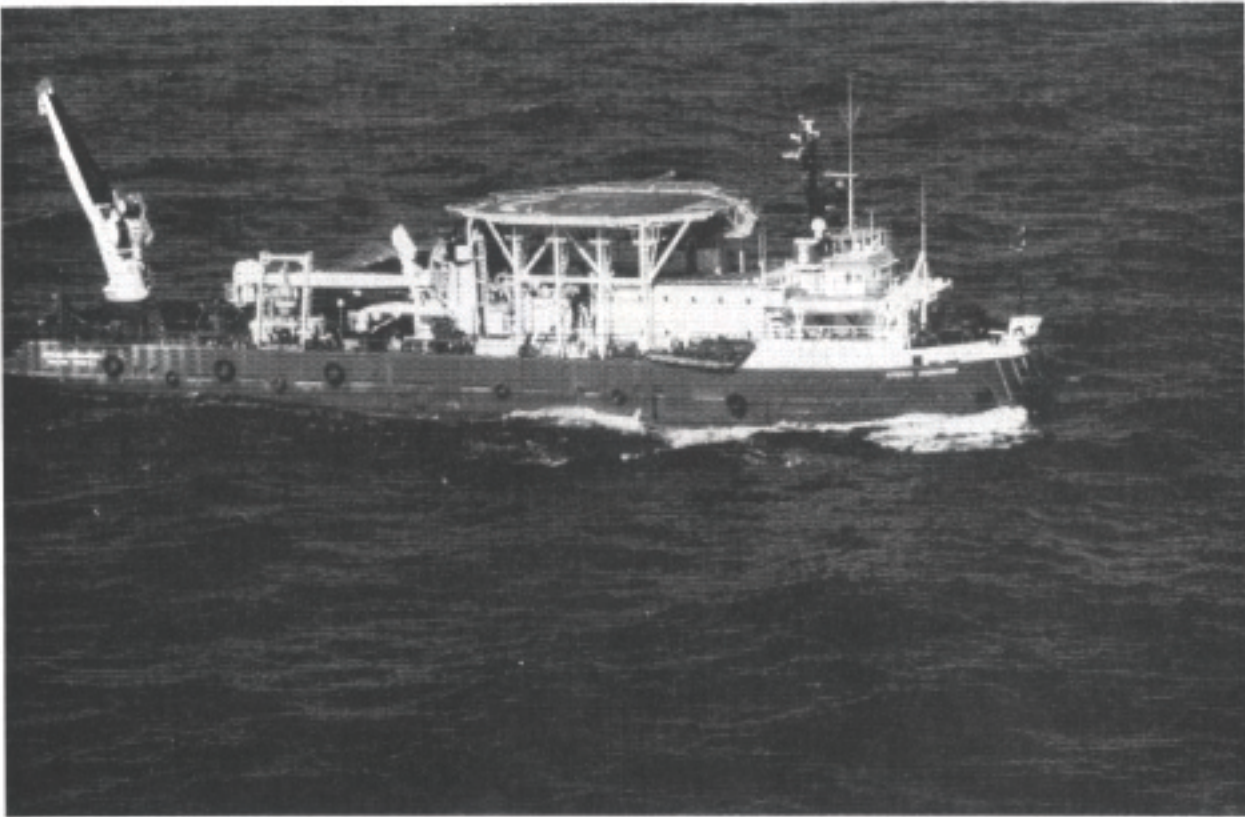
STENA WORKHORSE. The principal deep water salvage vessel was STENA WORKHORSE. STENA WORKHORSE had dynamic positioning and four-point mooring capability, ample open space on the after deck for supporting ROV operations and 100-ton lifting capacity. The ship was constructed for offshore oil work in the North Sea and was an excellent platform for recovery operations considering the mandatory requirement for dynamic positioning in deep water, the expected weight of objects to be recovered and anticipated sea conditions off Cape Canaveral.

Description: General purpose heavy work vessel

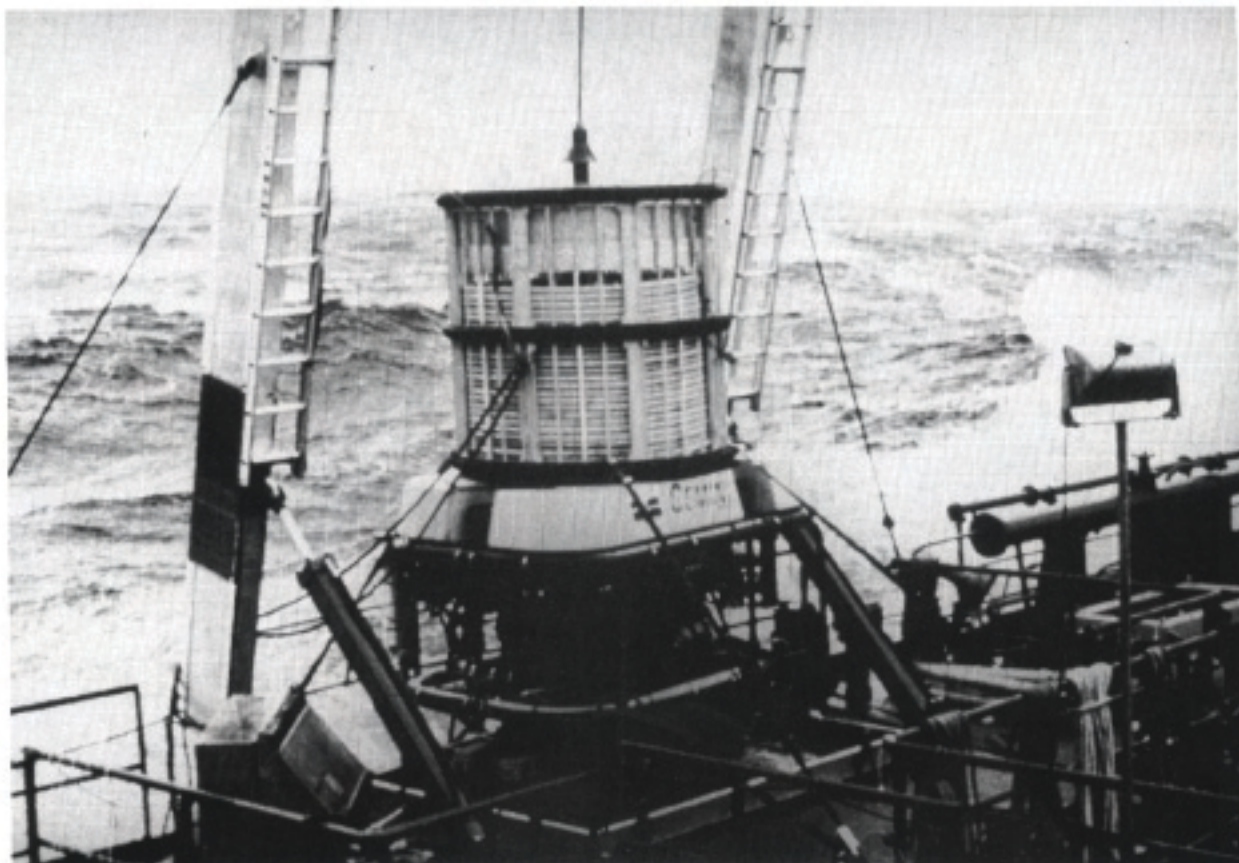
GEMINI

Description: A remotely operated, open frame highly adaptable subsea work system (depths to 10,000 feet)
